COMMISSION OF
INQUIRY INTO THE
AIR ONTARIO CRASH
AT DRYDEN, ONTARIO

Final Report

Volume I

The Honourable Virgil P. Moshansky
Commissioner

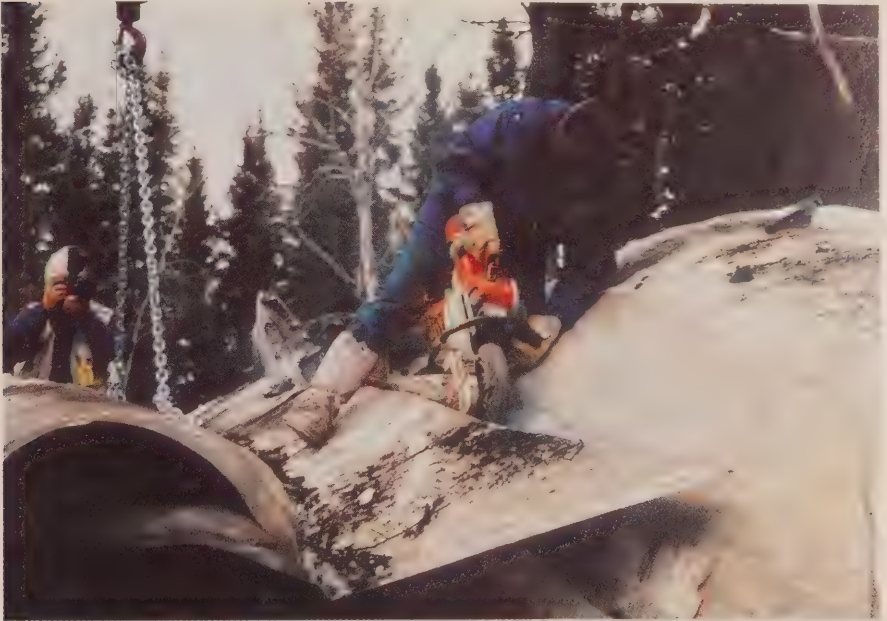
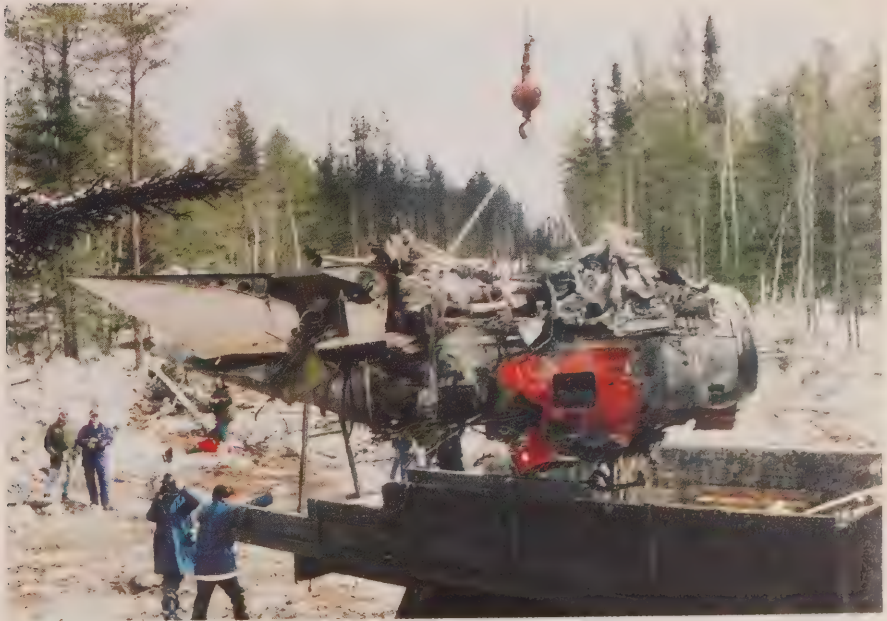
The wreckage was carefully photographed in situ at the crash site by the investigators: top, right engine; bottom, rear section of the right side of the fuselage.

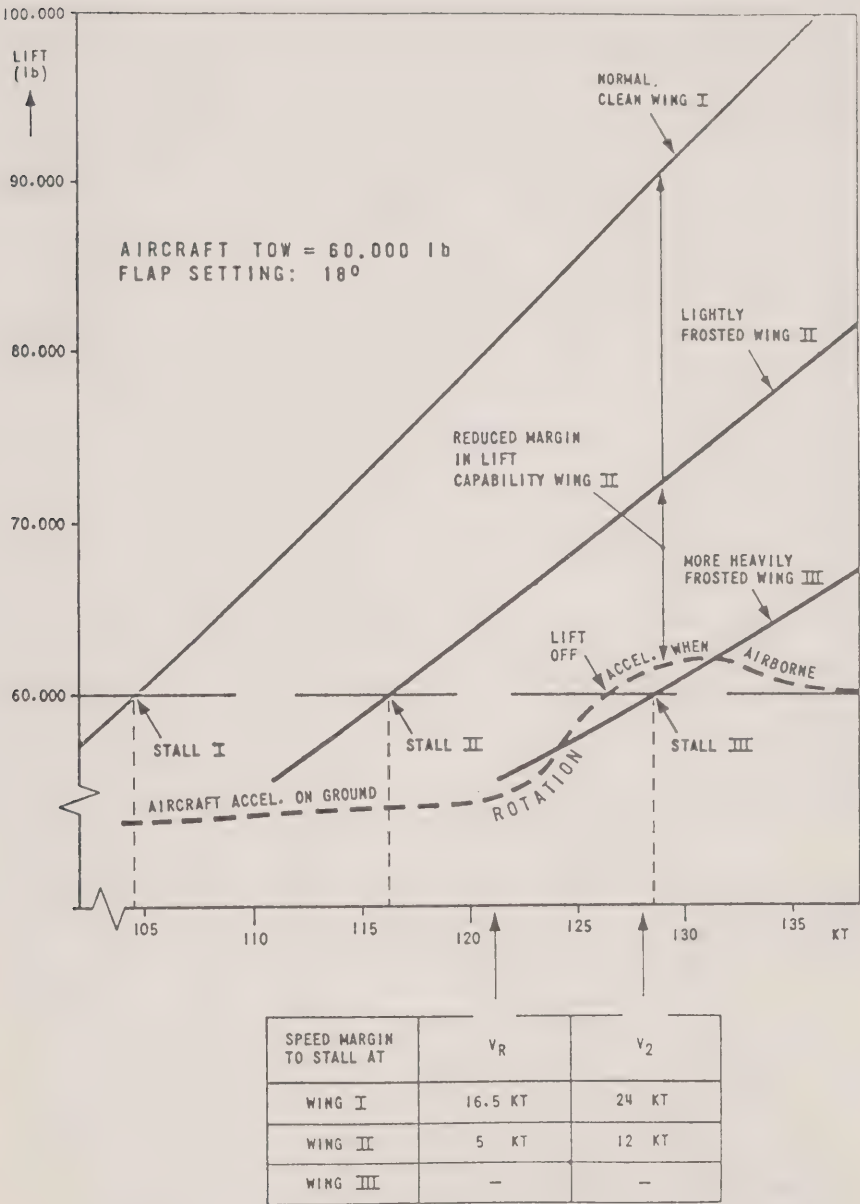
Figure 12-3 Comparative Margins for Two Arbitrarily Chosen Frost-Contaminated Wings and the Normal Clean Wing

Up to a point, as figure 12-3 indicates, the more the wings were contaminated the greater the loss of lift. For example, during takeoff at a weight of 60,000 pounds, with 18° of flap and with a clean wing, the stalling speed of the aircraft was about 104 knots. With the wing lightly frosted, the stalling speed was about 117 knots, and with the wing heavily frosted, about 128 knots. The V_R speed (takeoff rotation speed)⁵ for the aircraft was 121 knots and the V_2 (takeoff safety speed)⁶ was 127 knots. With a clean wing, the speed margin at rotation speed before stall was approximately 17 knots. With a lightly frosted wing, the margin was 5 knots. With a heavily frosted wing, the wing was in a stalled condition as it was rotated.

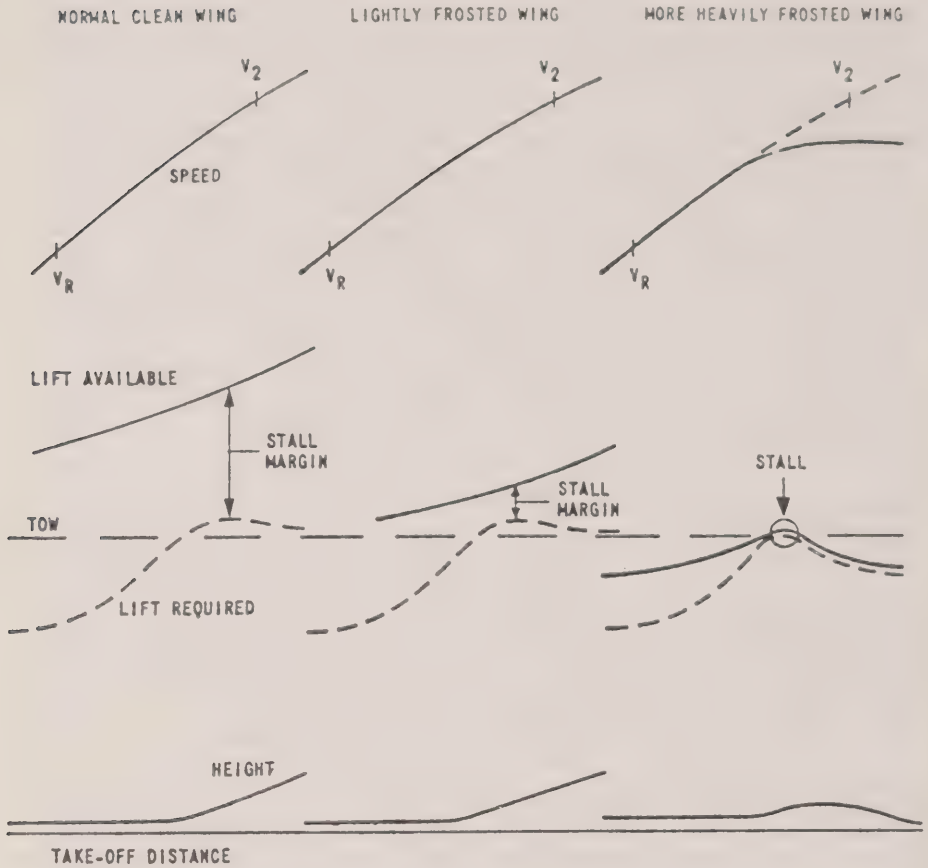
Figure 12-4 Comparative Stall Margins¹

Figure 12-4 describes the decrease in stall margin between a normally clean wing and a lightly frosted wing and demonstrates that an aircraft

¹ Illustrates differently the comparative stall margins for the same (figure 12-3) two arbitrarily chosen frost-contaminated wings and the normal clean wing.

with more heavily frosted wings is unable to sustain flight because the wing is in a stall condition at rotation.

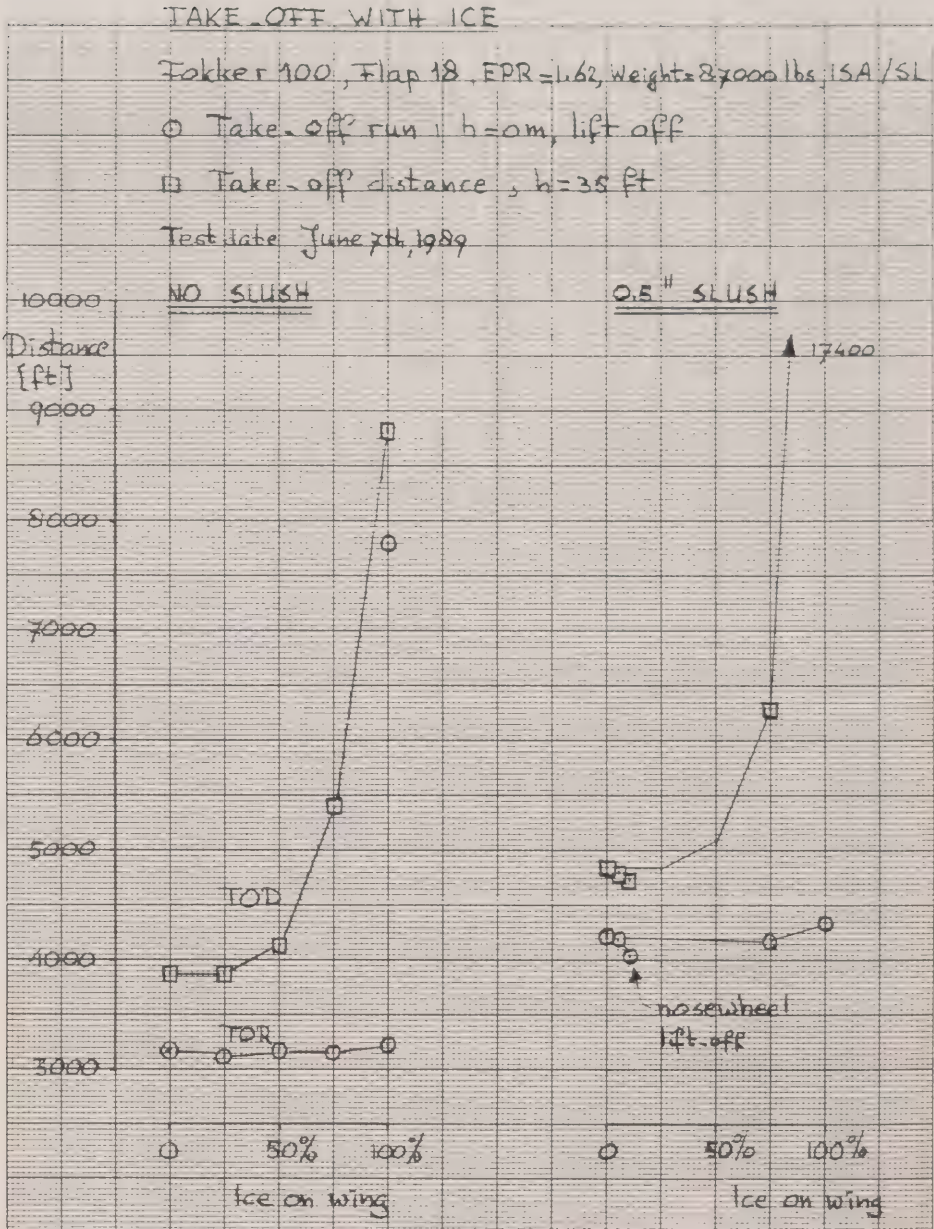
Figure 12-5 Fokker 100 Simulation of Takeoff with Ice, Flaps 18°

Figure 12-5 describes the Fokker 100 simulator with 18° of flap at sea level taking off with power and weight equal to full power on an F-28 at 63,500 pounds. By loading up the wing with contamination from 0, representing a clean wing, to 1.00, representing contamination in an amount equal to 1–2 mm diameter particles per square cm of wing surface, but with no runway slush, the takeoff run of the F-28 ranged between 3100 and 3250 feet. However, as contamination on the wing increased from 0.5 to 1.00, the takeoff distance increased from approximately 4150 to 8800 feet.

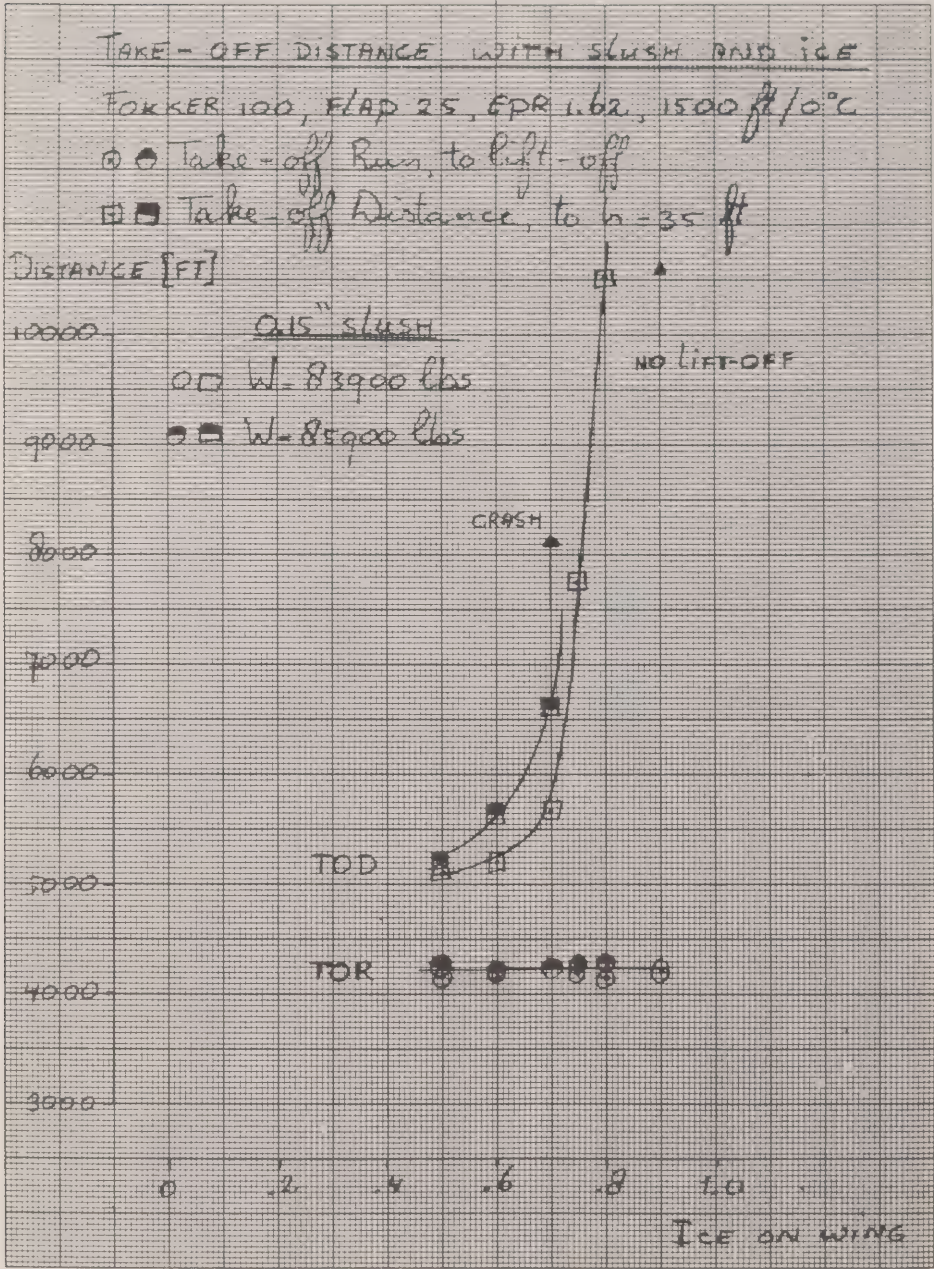
Figure 12-6 Fokker 100 Simulation of Takeoff with Slush and Ice, Flaps 18°

It was clearly revealed from the tests that by rotating the aircraft at a slower rate at V_R , the takeoff run increases slightly but the takeoff distance actually decreases. It was noted that, under similar conditions

of slush and wing contamination, with a slow rotation the takeoff run increased by 10 m (32.8 feet) from 1545 m (5070 feet) to 1555 m (5100 feet) while the takeoff distance actually decreased 435 m (1427 feet) from 2285 m (7495 feet) to 1850 m (6070 feet).

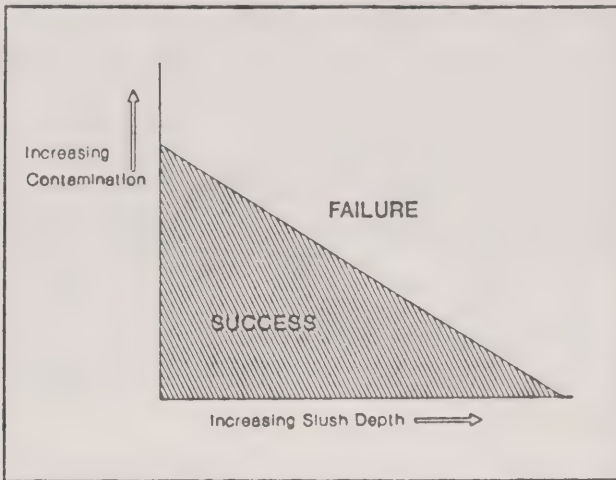
Figure 12-8 A Boundary Condition Plot for Successful Takeoff

The two “various boundary” plots in the “Flight Dynamics” report (p. 77) represent the crux of the performance investigation. They show that it is possible to define two boundary conditions, in terms of combinations of slush depth and wing-contamination factor, that can lead to catastrophic results during attempted takeoffs. A boundary condition here means “a continuous relationship between level of contamination and runway slush depth which represents the dividing line” between a successful or unsuccessful takeoff (pp. 73–74). This boundary relationship, which is illustrated in the “Flight Dynamics” report, is reproduced below as figure 12-8. The “various boundary” plots (figures 6 and 7 in the “Flight Dynamics” report) can be interpreted according to figure 12-8, below.

Figures 8a–10b of the “Flight Dynamics” report illustrate in detail the various test runs. A review of the figures reveals that there are well-defined boundaries of slush depth and contamination level that either allow or prevent the aircraft from flying successfully. For example, with a rotation speed (V_R) of 122.5 knots, a slush depth of 0.25 inches, and a wing-contamination level of 0.65, the aircraft flies away. At 0.68 wing contamination, the aircraft gets airborne, but, 500 feet beyond the end of the runway, it is only at 10 feet. At 0.69 contamination, the aircraft returns to the runway and runs off the end. In another example, with a rotation speed of 127.5 knots, a slush depth of 0.10 inches, and a wing-contamination level of 0.823, the aircraft flies away despite two bursts of stick-shaker. At 0.824 wing contamination, the aircraft height never exceeds 5 feet, and it eventually returns to the surface 1100 feet beyond

the end of the runway. The figures also demonstrate that pilot technique can have a marked effect on the success or failure of a takeoff.

The implication of the results presented in this section of the “Flight Dynamics” report, especially the two sets of boundary conditions, is that there “exists a combination of values of slush depth and wing contamination which can cause aircraft trajectories of the type described by witnesses to the Dryden accident” (Exhibit 526, p. 75).

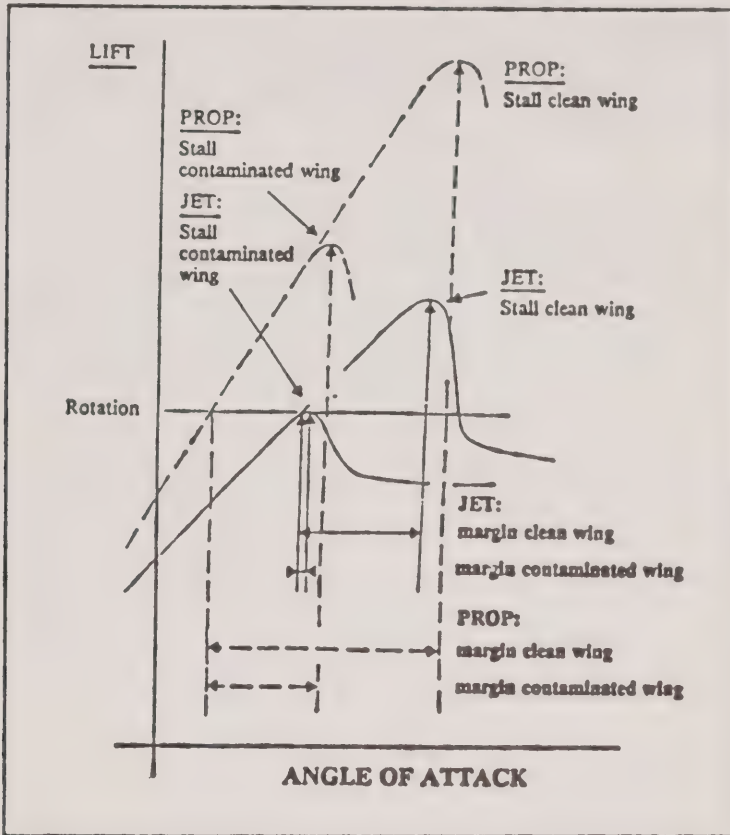
Figure 12-9 Jet- and Propeller-Driven Aircraft Comparison

this class, that is, to any jet-propelled, swept-wing aircraft. There is, however, a more severe performance penalty paid for contamination of a jet-propelled aircraft than for contamination of a propeller-driven aircraft. The shallower lift curve slope and the reduced maximum coefficient of lift of the swept wing make its performance more readily degradable. As well, the jet aircraft does not have the advantage of a relatively large area of its wing being immersed in high-velocity air from the propeller slipstream. The jet aircraft's only lift-producing capability is the result of the aircraft motion relative to the air. Diagrams in Fokker's Report no. L-28-222 (technical appendix 2 to the Final Report) and the "Flight Dynamics" report (technical appendix 4) show performance comparisons between jet- and propeller-driven aircraft when their wings are contaminated. Figure 12-9, from the "Flight Dynamics" report, depicts the comparison.

It was determined that a clean wing with the benefit of high-energy propeller-driven airflow would achieve about 25 per cent additional maximum coefficient of lift (C_{LMAX}) at takeoff speeds compared with the same wing without the benefit of propeller airflow. For a contaminated wing with propeller airflow, the C_{LMAX} would be similar to that of the

same clean wing without propeller airflow. For a contaminated wing of a propeller-driven aircraft where the propeller airflow is lost (engine stoppage), the C_{LMAX} would be approximately the same as that of a contaminated wing of an aircraft that does not have the benefit of propeller airflow (jet aircraft).
